NATIONAL TRANSPORTATION SAFETY BOARD

HAZARDOUS MATERIALS ACCIDENT REPORT

DERAILMENT OF
A CSX TRANSPORTATION FREIGHT TRAIN
AND FIRE INVOLVING BUTANE
AKRON, OHIO
FEBRUARY 26, 1989

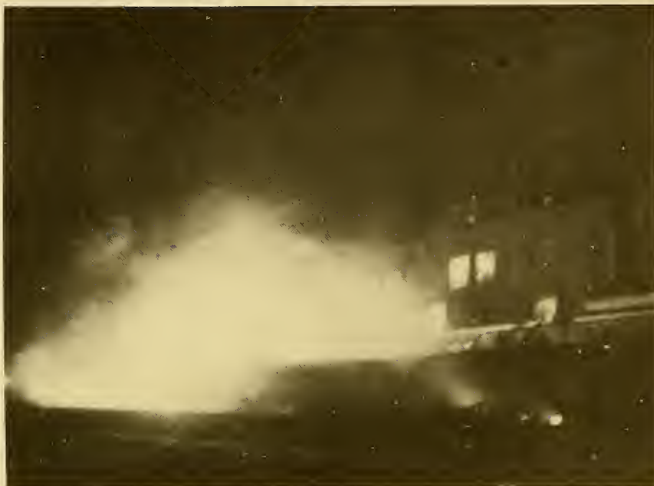
Figure 4.--Derailed tank cars adjacent to building 315.

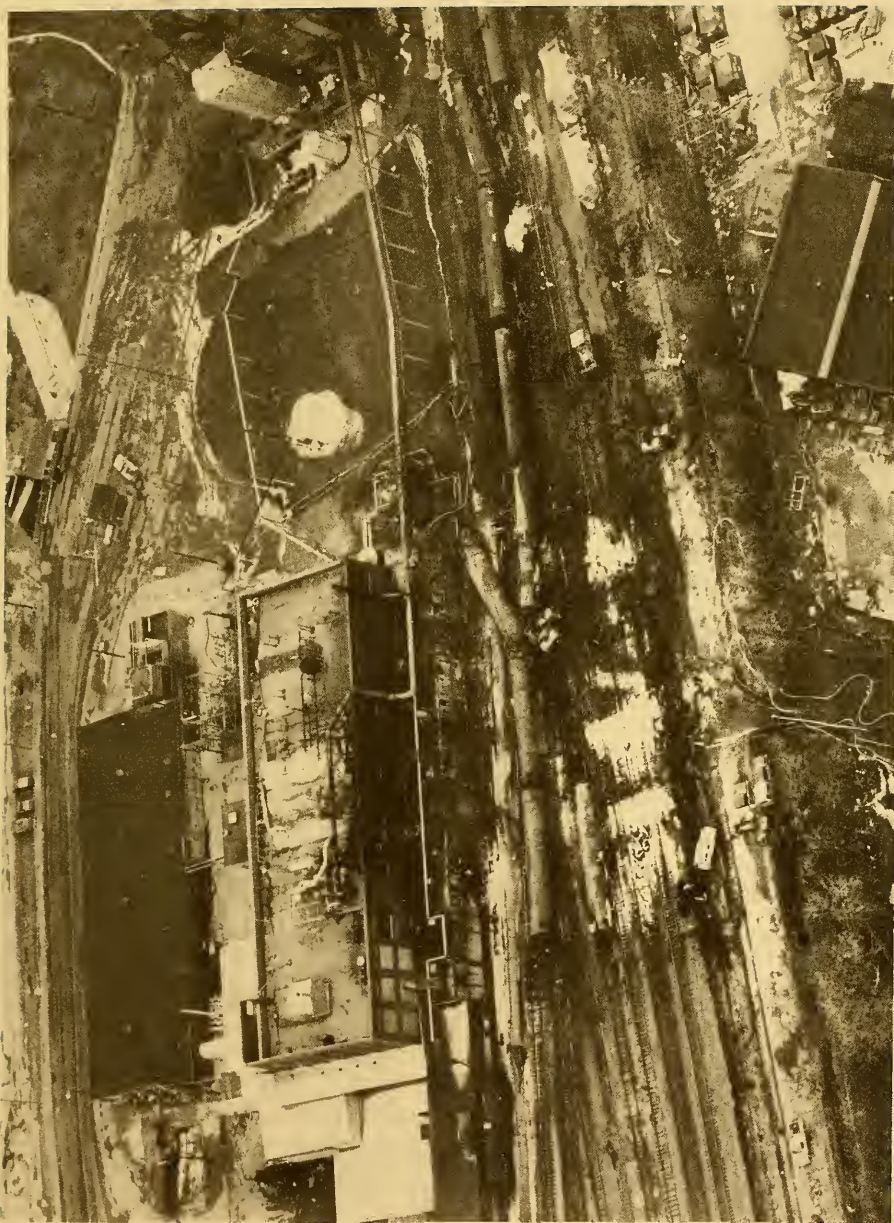
Figure 6.--Aerial view of derailment site. Some tank cars had been moved during wreckage clearing operations.

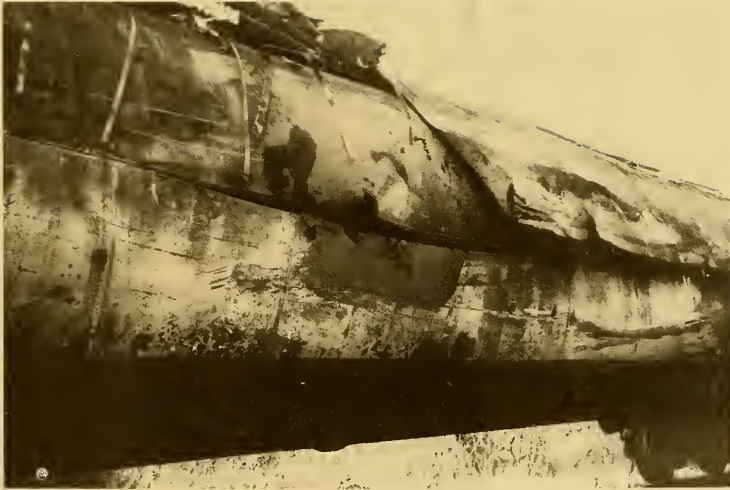
Figure 7.--Tank car UTLX 88119.

About 11:45 p.m., the CSX hazardous materials supervisor entered the derailment site to assess the damage to the tank cars. As a result of this inspection, he made the following observations: (1) tank car UTLX 88119 was probably in tact with no evidence of leakage; (2) flames were burning at one end of tank car CITX 33875; and (3) flames were burning near the dome of tank car ZIPX 3382, which was overturned; he estimated that one end of this car was located 4 to 10 feet from the northwest corner of building 315 (figure 6). He took notes on the position of each tank car and later constructed a diagram of the car positions. While at the derailment site, the CSX hazardous materials supervisor also observed that firefighters were on the roof of building 315 fighting a roof fire, and that the ground fire from released butane had been extinguished. About 1:00 a.m. on February 27, two B.F. Goodrich employees were allowed to enter building 315 to check the cooling system that controlled reactions of butadiene and acrylonitrile in the latex manufacturing process. The cooling system functioned properly throughout the incident. According to the B.F. Goodrich plant manager, had

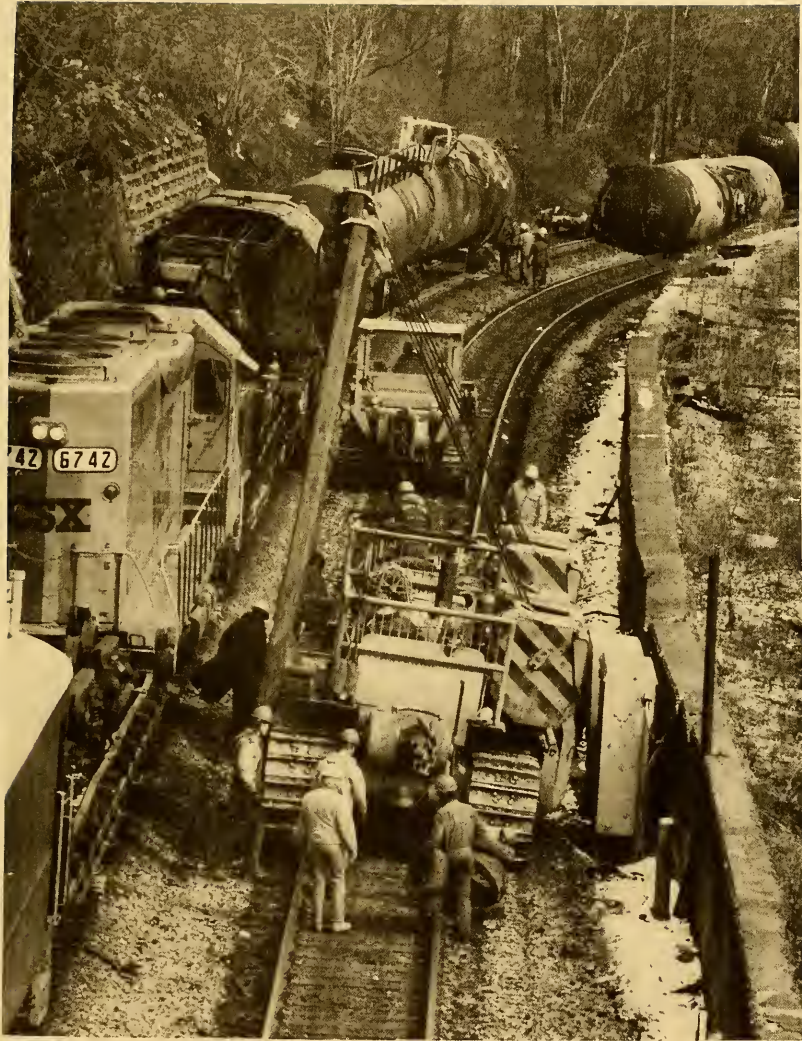
Second Event Involving Tank Cars.--About 4:00 a.m. on February 28, the wreck train began its movement to the Akron Junction yard. The plan was to move at about 2 to 3 mph, walking speed. Conrail and CSX employees rode on the train to observe the tank cars. As the engines began to pull the train, a chain between the first and second cars came loose; it was reapplied and adjusted. The engines again began to pull and the same chain broke. The cars were again chained together, and after moving about 1/2 mile, the chain between the first and second cars broke again. Another chain was then applied and the tank cars were inspected. Tank car GATX 83935 was found to be leaning, and when the train moved to take up slack, sparks were seen beneath the car. A wheel was found to be cutting the tank car steel jacket but it was not believed to have damaged the tank shell; therefore, jacks were used to raise the tank and additional wooden chocks were added between the tank and the truck.

Figure 8.--Site of second event.

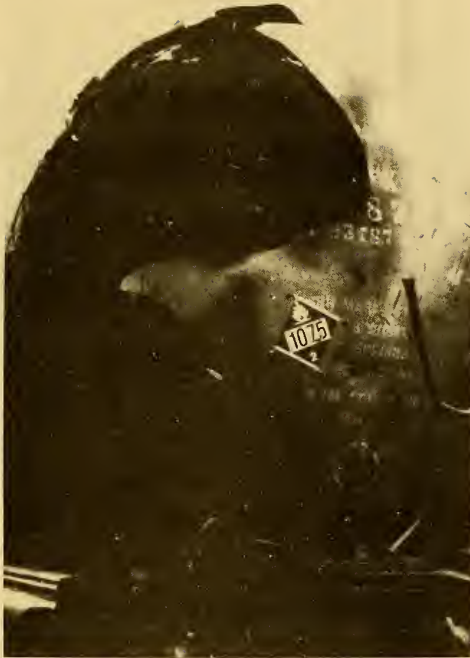
Figure 9.--Tank car ZIPX 3382.

After returning to the command post, the CSX hazardous materials supervisor expressed his concern to the operations chief that the overturned tank car (ZIPX 3382) had a fire near the dome, and that the pressure relief device, equipped on top of the car, may not function because of the orientation of the car. Without proper functioning of the device, he said there was potential for a violent thermal rupture of the tank car.

ZIPX 3382 (DOT specification 112J340W). The tank car jacket displayed evidence of moderate burn damage, flame impingement, wrinkles and bulges from heat exposure, and tears. The top half of the B-end tank head sustained an impact that resulted in a dent, and about one-third of the head shield was missing (figure 9). The A-end coupler was missing and a body bolster at the B-end was missing.

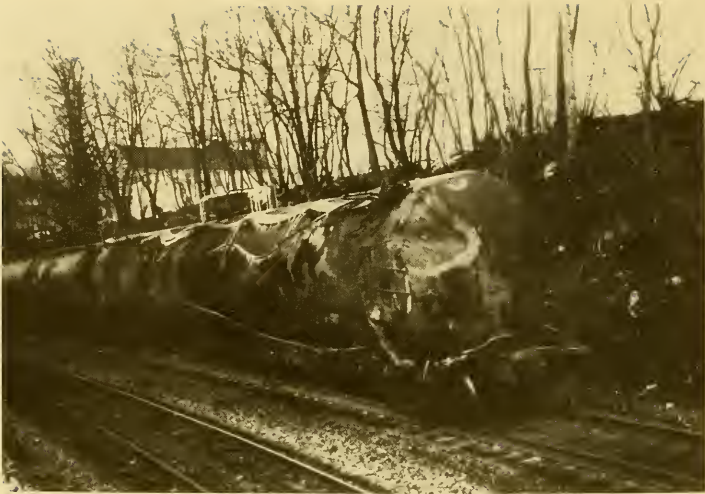
Figure 10.--Tank car BCDX 474.

BCDX 474 (DOT specification 105J300W). The A-end head shield sustained three impact dents, one about 4 feet in diameter in the top half (figure 10). The jacket on top of the tank sustained dents of about 2 feet and 1 foot in diameter. The tank car jacket sustained tears and wrinkles from heat exposure.

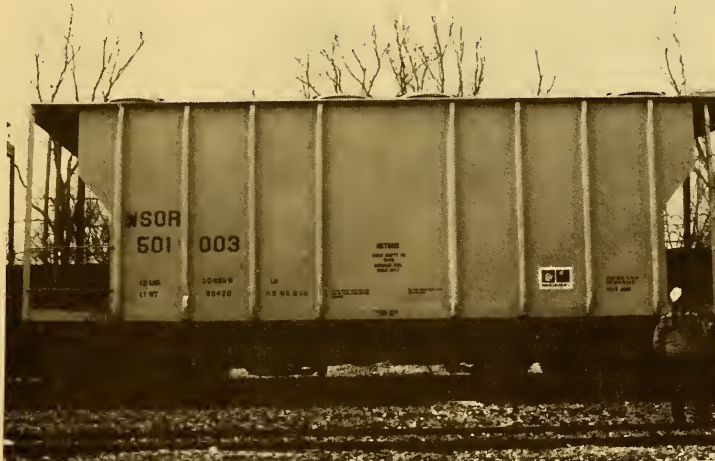
Figure 11.--Freight car WSOR 501003.

After the derailment near the B.F. Goodrich plant, WSOR 501003 was observed turned over on its left side (direction of movement of the train). The A-end truck was separated from the car and was found about 50 feet south of the derailed car. The B-end truck, which was the lead truck in the direction of movement of the train, was also separated from and in line with the car. Heavy rail burns were observed on the left sideframe of the B-end truck and wheel marks were observed on the left side cross-ridge slope sheet of the car (figure 12). Additionally, the lead wheelset showed evidence of heavy chaffing and bluish discoloration on the steel rims and flanges. Some of the springs were dislodged from the right sideframe of the B-end truck assembly. Figure 13 identifies some pertinent components of a truck assembly, including the bolster and sideframes.

After WSOR 501003 was rolled upright on its own trucks, the truck bolster on the A-end of the car was observed to be a different design from the truck bolster on the B-end of the car, and that the truck bolster pattern numbers were different. The A-end pattern number was Scullin AAR-B-1925 and the B-end pattern number was Gould-B-9S-14EJ-BX.

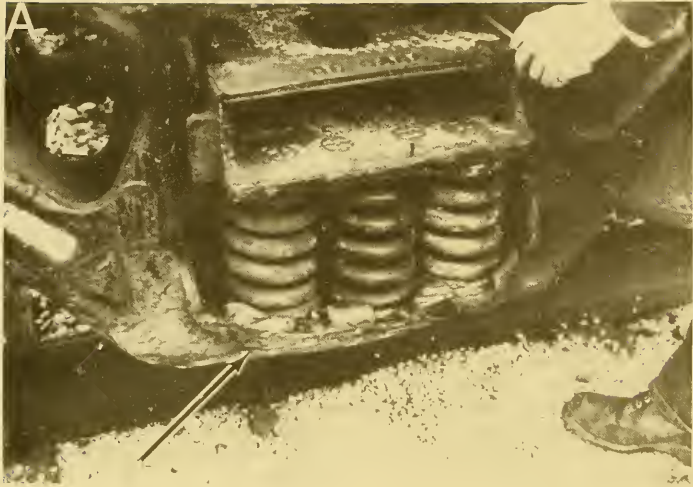
Figure 12.--Some of the damage observed on car WSOR 501003:
(A) rail burn on sideframe, (B) wheel marks on slope sheet.

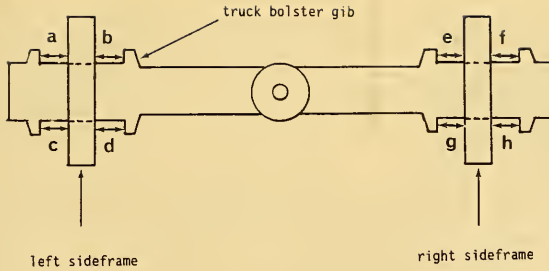
$a = 2$ inches	$e = 1 \frac{7}{8}$ inches
$b = 1 \frac{1}{4}$ inches	$f = 1 \frac{1}{4}$ inches
$a + b = 3 \frac{1}{4}$ inches	$e + f = 3 \frac{1}{8}$ inches
$c = 2$ inches	$g = 1 \frac{3}{4}$ inches
$d = 1 \frac{3}{16}$ inches	$h = 1 \frac{3}{8}$ inches
$c + d = 3 \frac{3}{16}$ inches	$g + h = 3 \frac{1}{8}$ inches

Figure 14.--Gib clearances measured between truck bolster gibs and sideframes on the B-end of WSOR 501003.

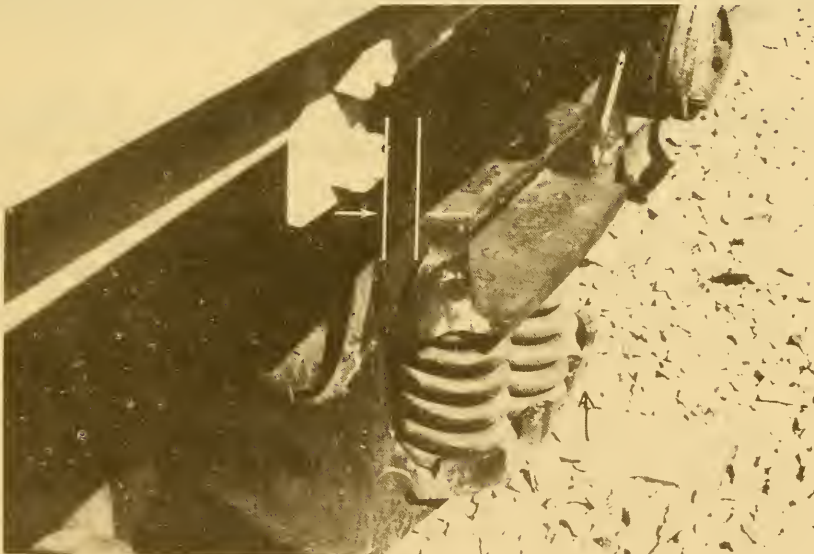
Figure 15.--Gib clearance visible outside the sideframe.

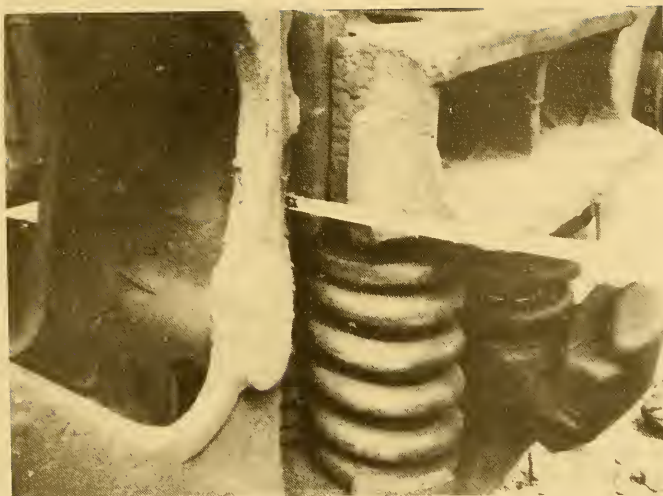
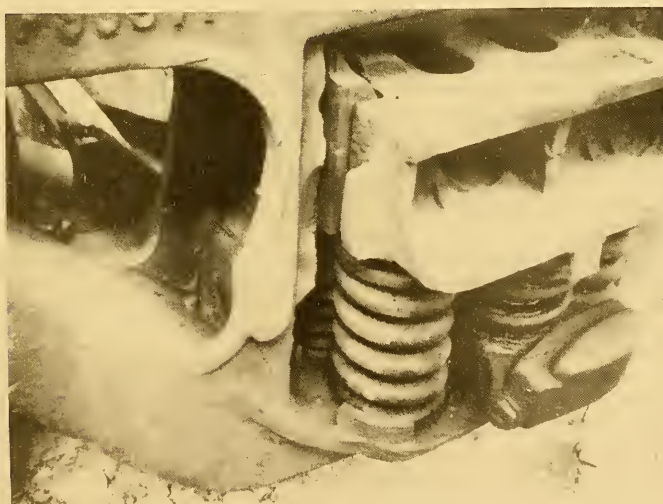
Other Car Repair Information.--Following the postaccident detection of the mismatched truck bolster on WSOR 501003, the owner of the Wisconsin & Southern Railroad told his car inspectors to look closely for mismatched bolsters on other cars. On May 10, 1989, Wisconsin & Southern Railroad car inspectors found a freight car with excessive gib clearances. This car, CNW 69883, was loaded with sugar and offered at interchange by the Chicago and North Western Transportation Company. The sideframes at both the A- and B-ends had been damaged as a result of contact with the truck bolster (figure 17).

Figure 17.--Damage to the sideframes of car CNW 69883.

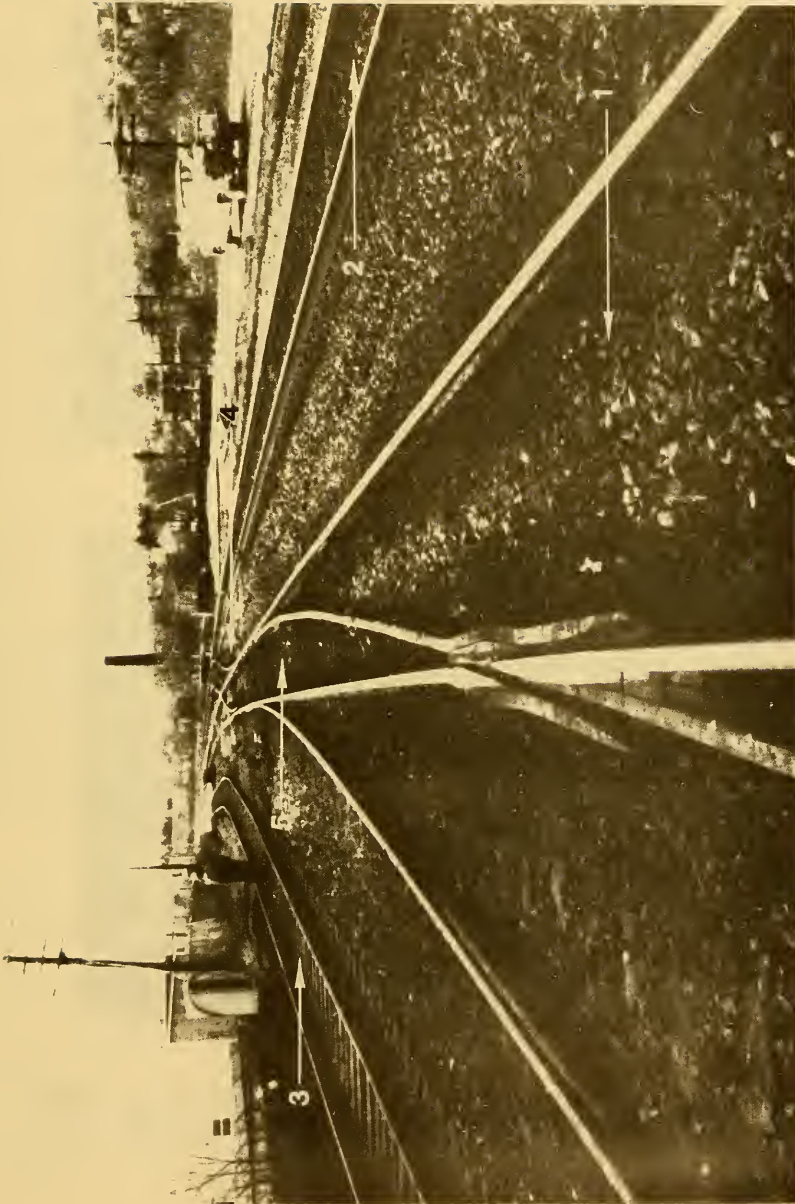
Description of Physical Evidence.-- A postaccident inspection of the track approaching the point of derailment revealed discrepancies in the curve alignment and the track surface. The uniform alignment of the 1 degree 30 minute curve was interrupted by segments of irregular alignment caused by the presence of two turnouts located in the body of the curve. Throughout the curve, the high rail was curve-worn. However, at the toe of the trailing point frog, the rail wear tapered onto the closure rail for 14 feet, where it gradually tapered to no curve wear. Twelve feet north of the point where the high rail wear ended, wear was visible on the low rail for about 17 feet.

Figure 18.--View of tracks at accident site facing south. Arrows identify the following: (1) northbound track, (2) southbound track, (3) auxiliary track, (4) first turnout (direction of train movement), and (5) second turnout and area of point of derailment.

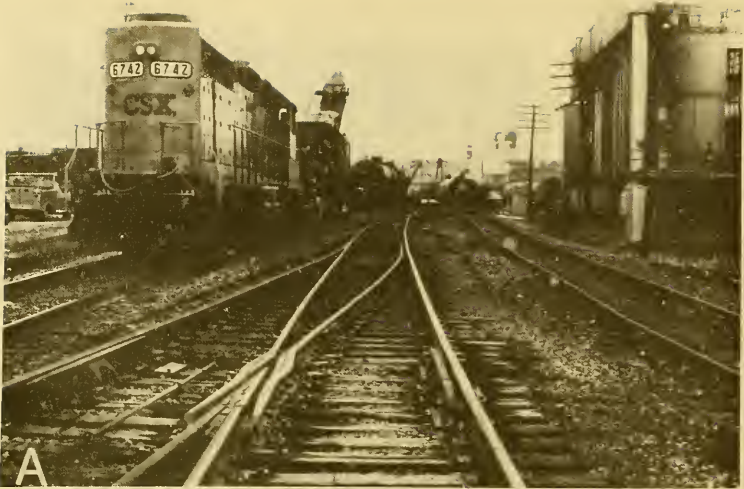
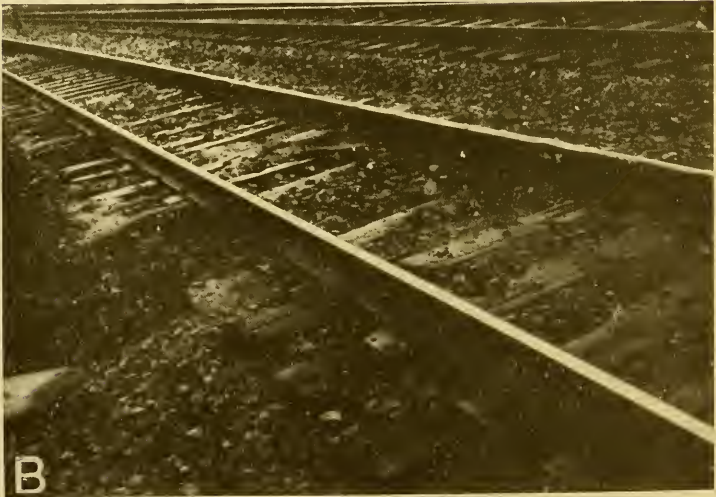
Figure 19.--Muddy track conditions on the northbound track: (A) at the turnouts, and (B) at the bridge south of the derailment site.

An abrasion was found on the receiving end of the guard rail in the trailing point turnout. The abrasion was on the guard face wing, about 1 1/2 inches beyond the area of normal contact between the back side of the car wheels and the guard rail. The abrasion was oxidized with a brightly colored rust, consistent with recent origin. The source of the abrasion could not be determined. Additionally, rail corrugation, caused by wheel forces, was found near the bridge immediately south of the accident site (see figure 19B).
